Upper Two Lick Creek Watershed (Indiana County) Assessment and Restoration Plan

June 2025

Report prepared by Hedin Environmental for the Indiana County Conservation District and Blacklick Creek Watershed Association

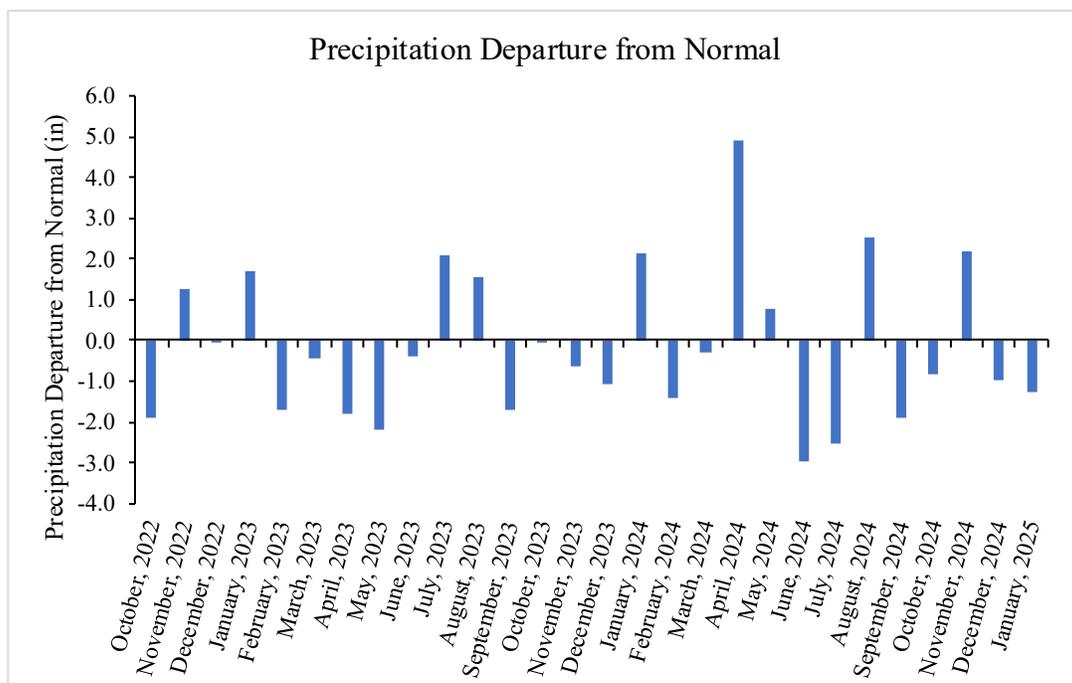
Figure 1 compares historic precipitation to the precipitation during the study period. Historic precipitation was determined as the average total monthly precipitation from 2012 through January 2025. Total historic precipitation over these months was 96 inches. Total actual precipitation over this study was 92 inches. The study period was, on average, slightly drier than the past decade.

Figure 1: Total monthly precipitation during the study period minus historic precipitation.

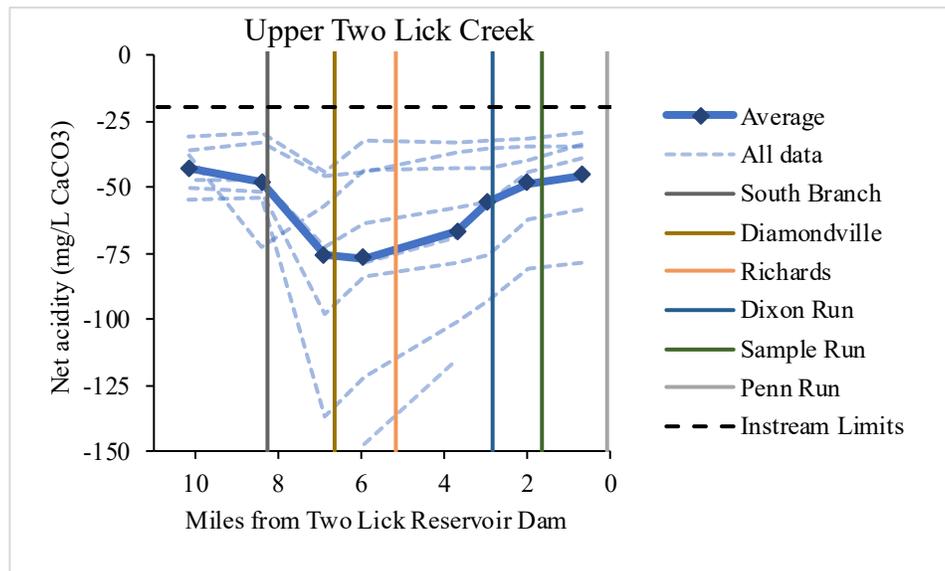
Figures 2 through 6 show a variety of instream water quality data at the instream locations. These figures illustrate that the entire length of UTLC was generally good quality. Figure 2 shows UTLC was net alkaline from the headwaters to the reservoir with average alkalinity concentrations ranging from 91 to 54 mg/L. For the entire length of UTLC, Fe concentrations were less than 1.2 mg/L (Figure 3), and Mn concentrations were less than 0.3 mg/L (Figure 5). On average, pH was around 7 for the length of UTLC (Figure 6). Aluminum concentrations varied from less than 0.5 mg/L in the headwaters to 0.9 mg/L near the mouth (Figure 4). Table 4 presents the average instream water quality for instream sampling locations from the headwaters to the reservoir.

Figure 2: Instream samples graphed showing all sampling events and the average net acidity.

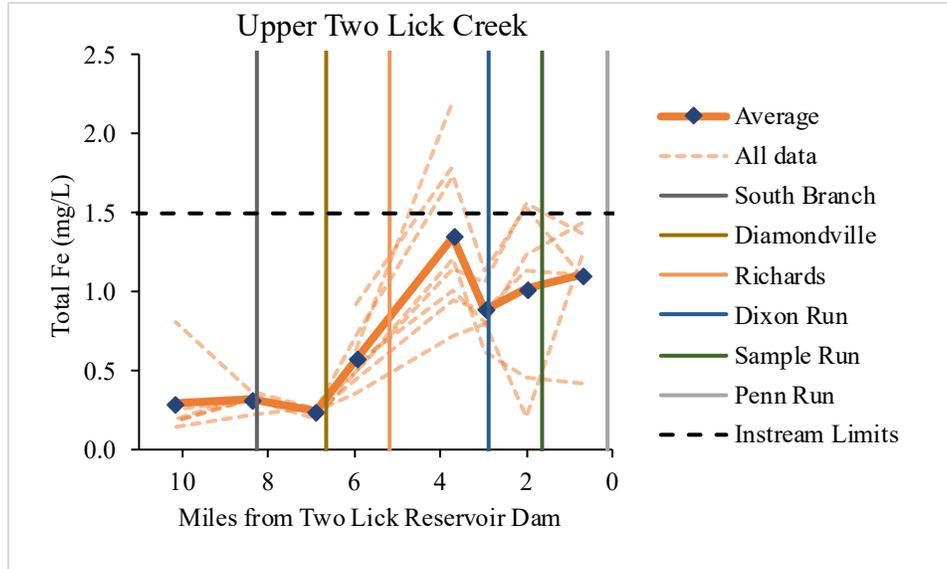
Figure 3: Instream samples graphed showing all sampling events and the average total iron concentrations.

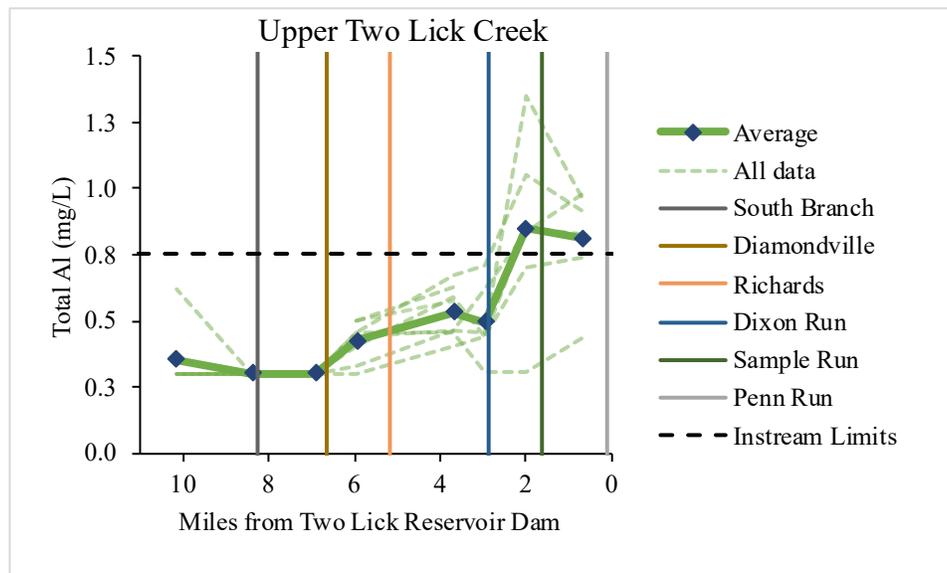
Figure 4: Instream sampling graphed showing all sampling events and the average total aluminum concentrations.

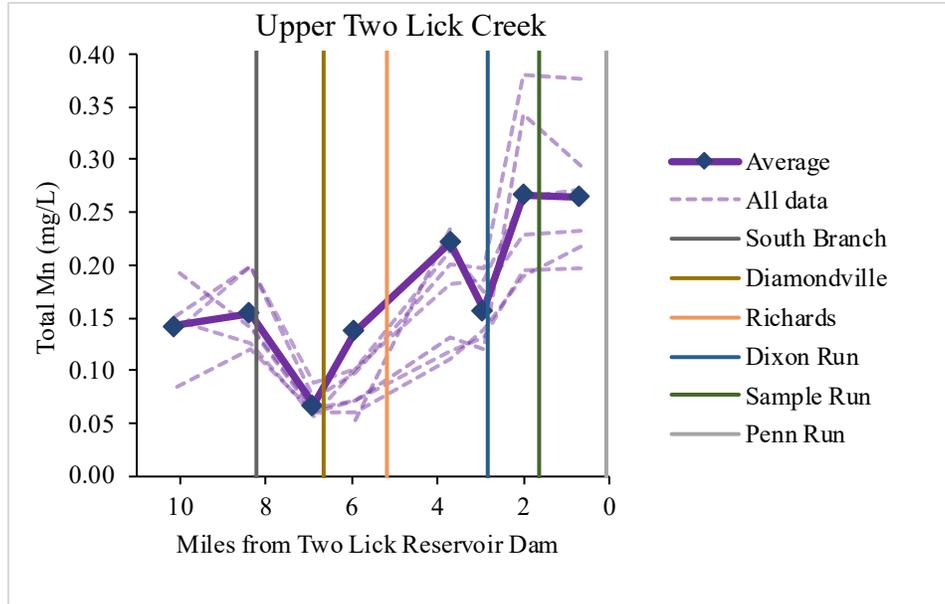
Figure 5: Instream samples graphed showing all sampling events and the average total manganese concentrations.

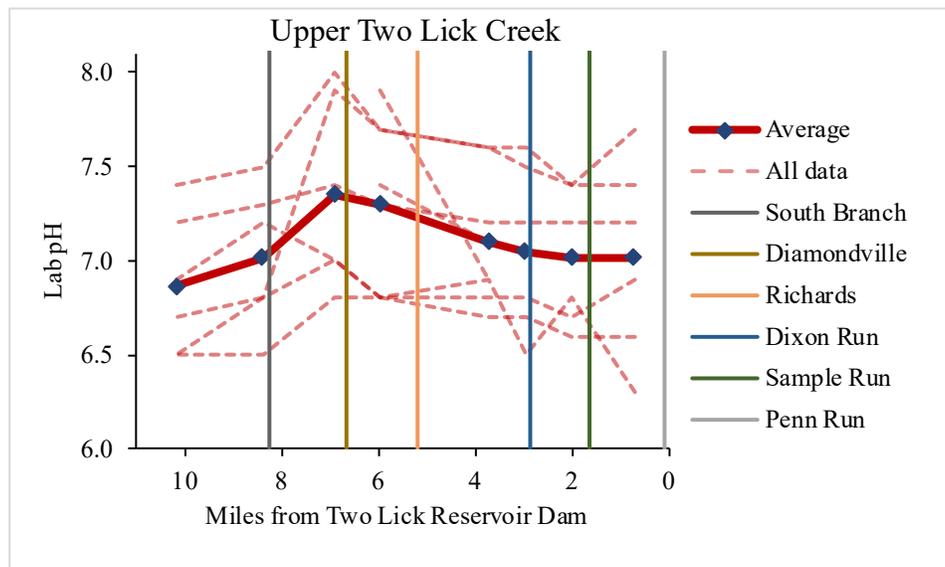
Figure 6: Instream samples graphed showing all sampling events and the average lab pH values.

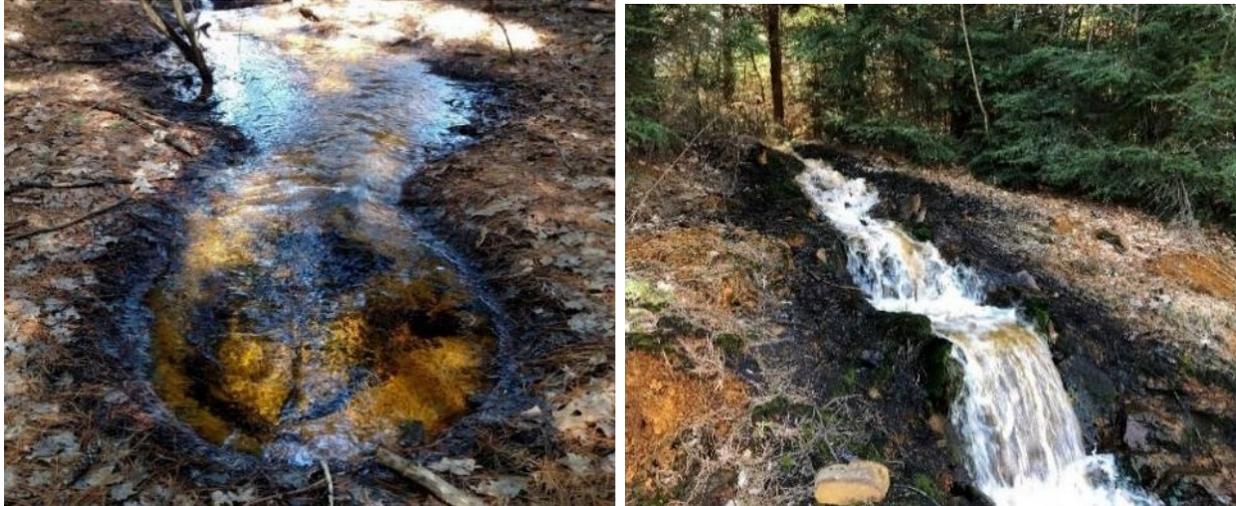
The Diamondville borehole (D2) is a discharge located 6.7 miles upstream of the reservoir near the town of Diamondville. As displayed in Photo 1, this is a point source discharge from an abandoned borehole into the Mack #2 mine that then flows about 100 feet into UTLC. It is not listed in PADEP's AML inventory.

Photo 1: Diamondville borehole upwelling from the mine (left) and entering UTLC (right).

3. Improve Two Lick Creek around the Richards Treatment System by treating discharges
 - a. Treating the Diamondville borehole would give the Richards area enough capacity to assimilate the smaller discharges there.

Overall, Diamondville borehole, Dixon AMD 2, and PD 1-4 discharges are recommended to be considered for addition to PADEP's AML database.

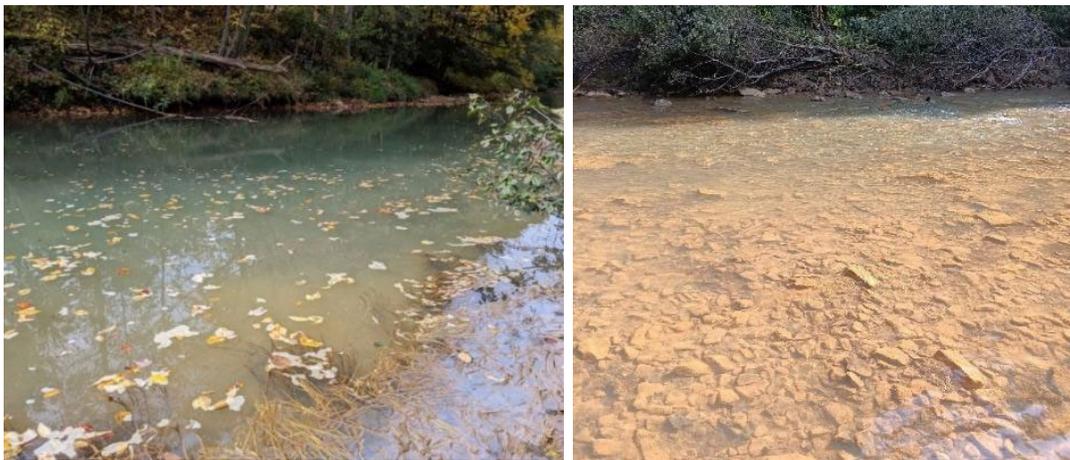
Photo 2 shows UTLC upstream of Buck Run with turbidity, a blue coloration from metals, and Fe solids coating the bottom of the stream channel.

Photo 2: UTLC downstream of the Richards area on 10/11/22 (left) and 8/23/24 (right).

Decreasing the amount of Fe leaving the Richards treatment system would help improve the biological conditions in this section of UTLC. Because of the elevated Fe concentrations in the #2 and #3 final effluent of the treatment system, there is a noteworthy amount of Fe precipitation in UTLC as the effluent from the treatment system mixes with it. While dissolved metals are

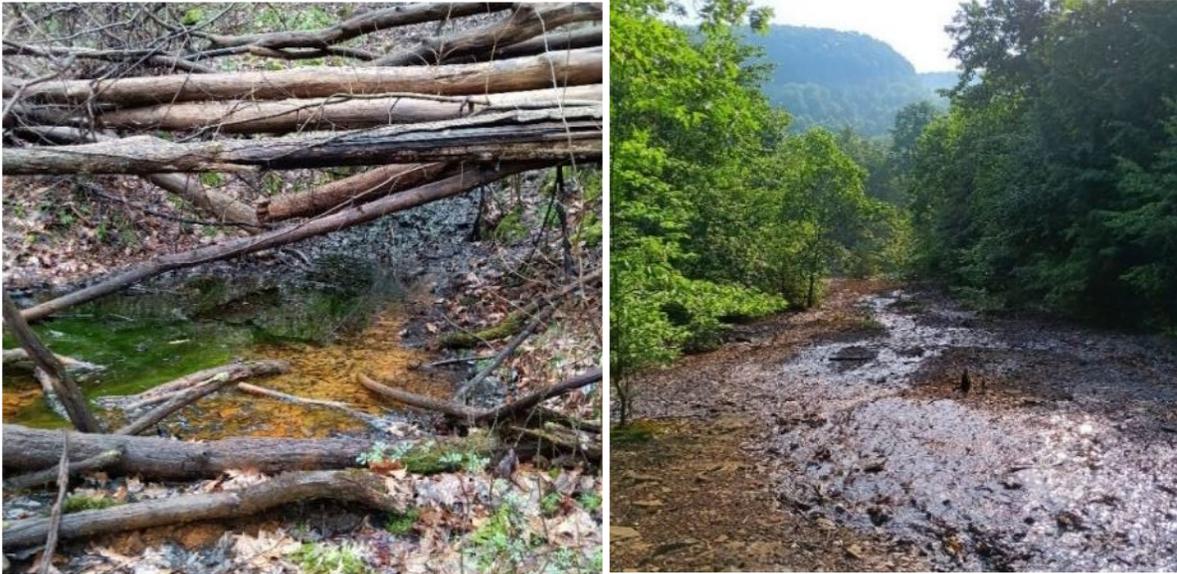
from an abandoned mine opening in the Swank #6 mine in the Lower Kittanning coal seam (Photo 3). There is a kill zone from where it exits the mine down a steep hill where it spreads out, until it is channeled into a drainage pipe under Route 403 and continues downhill until it enters UTLC. This discharge is referenced in the Operation Scarlift Report, is in AML inventory site PA 2438, and is near AML inventory point PA 2438-01.

Photo 3: Source of T1 discharge (left) and kill zone before it reaches Rt 403 (right).

- b. If treating the Diamondville borehole is not possible, then the T1 discharge should be the second priority for treatment.
4. Improve Sample Run by reclamation to reduce refuse seepage

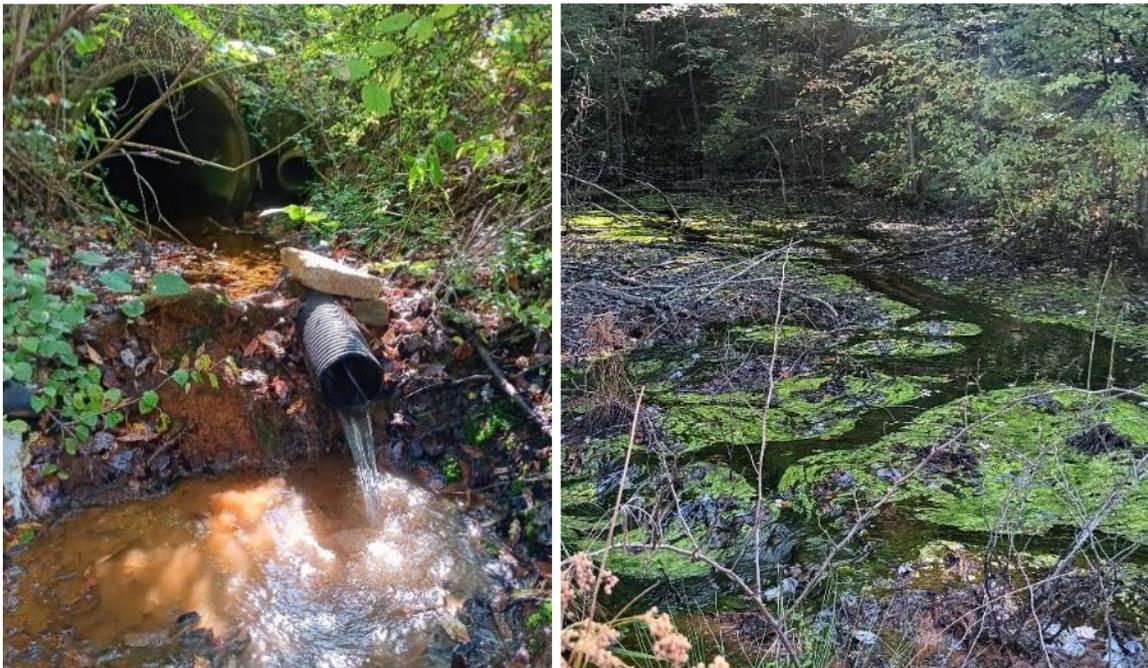
Downstream of Rosebud’s Clymer Prep Plant and near the mouth of Dixon Run, two significant discharges were Dixon AMD 2 and Dixon AMD 1 seen in Photo 4. Both discharges were high flow and polluted with acidity and high concentrations of Fe and Al. Both are referenced in the Operation Scarlift report, and they likely originate from the Victor #29 mine that is approximately 276 acres in the Lower Kittanning coal seam. Dixon AMD 2 originates from an abandoned mine opening and is in the Operation Scarlift report as a dry mine opening. It is not listed in PADEP’s AML database but is adjacent to AML inventory site PA 2432. Rosebud’s Clymer Prep Plant is just upstream of Dixon AMD 2’s source. Dixon AMD 1 is in AML

inventory site PA 2432 and near the location of AML point 2432-04 which is described as an abandoned untreated discharge.

Photo 4: Dixon AMD 1 before it reaches the railroad (left) and Dixon AMD 2 near its source (right).

Dixon AMD 2 and Dixon AMD 1 discharges were similar in chemistry. Dixon AMD 2 had a higher flow with an average of 163 gpm versus Dixon AMD 1 which had an average of 43 gpm. These two discharges had significant seasonal changes in flow. Figure 7 shows total monthly precipitation and discharge flow rates. In April 2024, which received an unusually large amount of precipitation, Dixon AMD 2 discharged 456 gpm, and Dixon AMD 1 discharged 159 gpm. Fe and Al concentrations increased 10 to 20mg/L above the average metal concentrations. This is characteristic of up dip draining mines like the Victor #29 mine. When precipitation increases, the mine pool elevation increases into areas of the mine with more acidic/reactive material due to its limited exposure to water in dry weather. This results in an increase in flow with more acidity and higher concentrations of metals than under normal flow conditions.

Dixon 3 is in AML inventory site PA 4027 but is not recorded as an AML polygon or point. Dixon AMD 2 is not in the AML database but is adjacent to AML inventory site PA 2432 which includes the Dixon AMD 1 discharge. Dixon AMD 1 and Dixon AMD 2 originate from the same mine workings, so Dixon AMD 2 is recommended to be added to PA 2432 as an AML point.

Dixon AMD 2 and Dixon AMD 1 discharges are the highest priority for treatment in the UTLC watershed as their treatment would remove the highest Fe loadings at 71 ppd and Al loadings at 86 ppd when combined. Treatment of both discharges would restore 1.1 miles of lower Dixon Run as it flows through the town of Clymer and would positively impact UTLC. While Dixon Run doesn't kill UTLC, it does cause Al to exceed instream standards. Therefore, approximately 2.1 miles of UTLC would also be improved by treating Dixon AMD 2 and Dixon AMD 1.

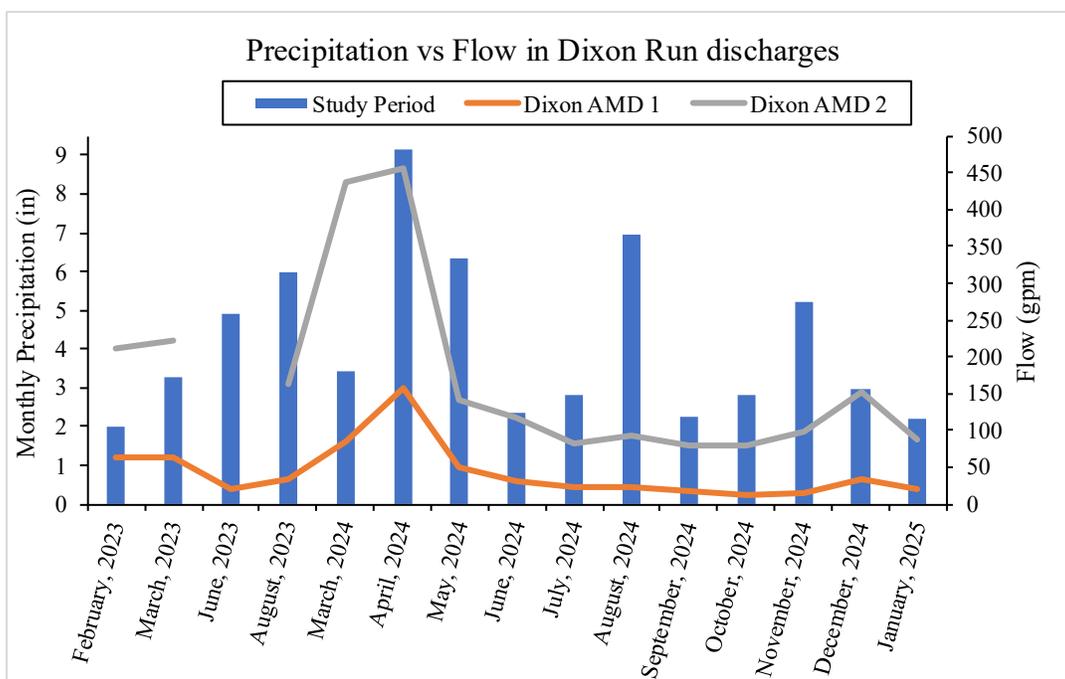
Conversely, the fall of 2024 received an unusually low amount of rain, and the discharges decreased in flow to their minimum recorded flow rates, and metal concentrations returned to average values. These discharges' flow rates were influenced by precipitation events and as such had variable flow rates and an increase in metals loadings during high flow events.

Figure 7: Monthly precipitation vs flow of the Dixon AMD 2 and Dixon AMD 1 discharges.

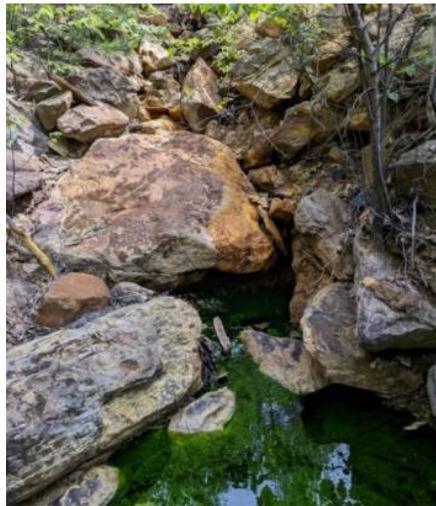
Photo 5 shows the refuse pile tributary under low flow conditions. As of February 2025, BAMR was in the process of investigating the composition of the refuse piles in Sample Run to determine if/how these can be reclaimed to remove their drainage as a pollution source for the stream.

Photo 5: Refuse pile tributary of Sample Run taken on 8/31/2023.

Table 20 shows the chemistry for the tributaries in Sample Run. The refuse pile trib contains severe AMD with 4,183 mg/L net acidity. The clean tributary was net alkaline and minorly diluted the effects of the refuse pile drainages.

- a. AML areas PA 2439-01 and PA 2439-02 should be reclaimed.
5. Improve the lower reaches of Penn Run by treating discharges
 - a. In the middle of Penn Run, five AMD discharges enter the stream. By treating three discharges, the lower reaches of Penn Run would be much improved.

While Sample Run did not degrade UTLC, AMD sources and dangerous abandoned mine infrastructure should be reclaimed to restore Sample Run.

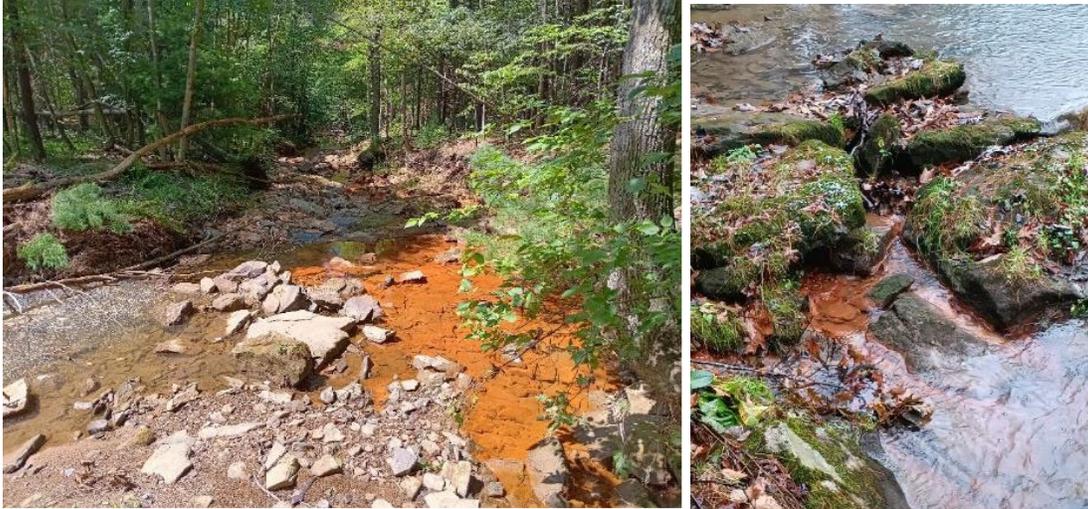
PR 1 was the first AMD input in Penn Run. Since it was a non-point source, approximate chemistry of the seepage was calculated by subtracting a downstream sample from an upstream sample on Penn Run. Photo 6 shows this seepage which seemed to originate from a point under large rocks near the bank of the stream.

Photo 6: Instream AMD seepage in Penn Run (left) and seepage under rocks where it originates (right).

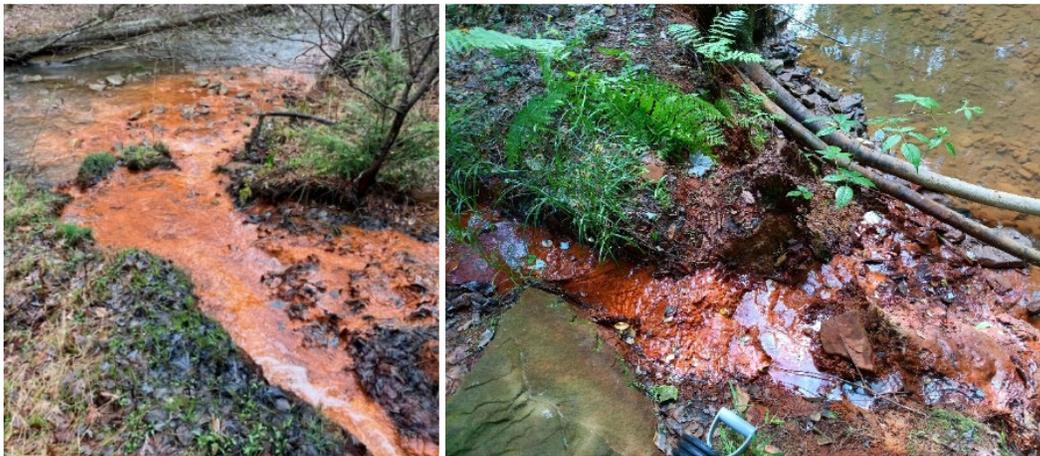
PD 1-3 are located within 130 feet of each other on the northern bank of the stream. These originated from seeps near the coal crop line of the Lower Kittanning coal, but it is possible they are draining from the abandoned Cherry Hill #2 surface mines (permits issued in 1960s). The discharges are adjacent to AML inventory site PA 0711. Photo 7 shows PD 1-3 discharges where they join Penn Run.

Photo 7: PD 2 and PD 3 joining before they enter Penn Run (left). PD 1 at its' confluence with Penn Run (right).

As a result, PD 2 and PD 3 were the most impactful discharges in the Penn Run watershed contributing a combined 44 ppd of Fe. MP7 added a significant amount of Fe and Al, but no point sources of these metals were found making it difficult to define and remediate.

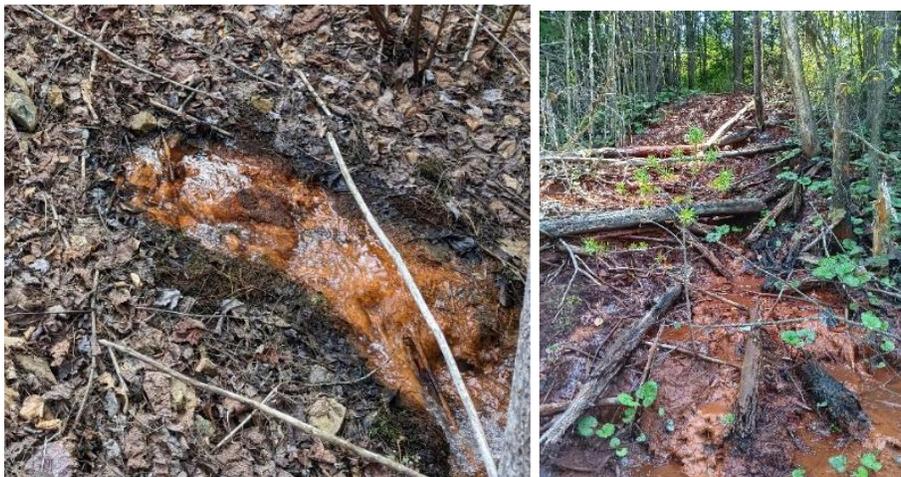
PD 5 was a point source located on the side of the berm of a pond. It was in AML inventory site PA 0711 and most likely drains from the Waterman #4-B mine in the Upper Freeport coal seam. While this discharge was not in the Operation Scarlift Report, the location of the pond was in the report as an old refuse pile in a strip mine area. Photo 8 shows PD 5 at its source and the Fe terracing it formed as it descended the steep hill to join Penn Run.

Photo 8: PD 5 source (left) and Fe terracing from the source to where it joins Penn Run (right).
